Technical Note N-1224

CORROSION OF ALLOYS IN HYDROSPACE -

189 DAYS AT 5,900 FEET

Fred M. Reinhart and James F. Jenkins

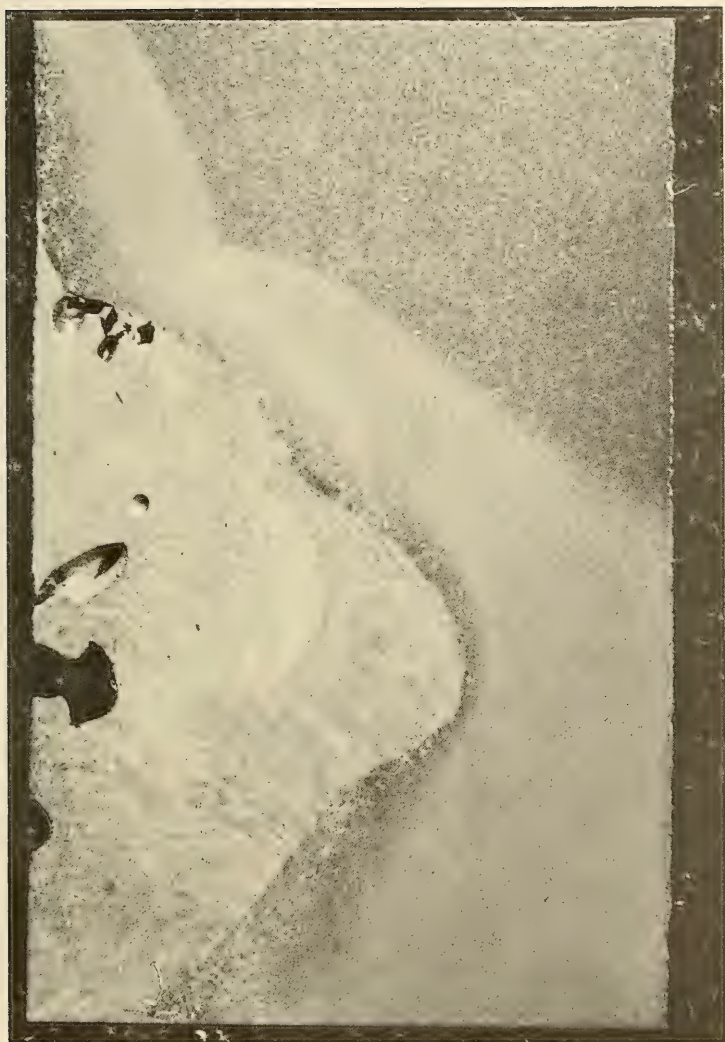
The pits in the weld bead of HS #4 were not typical of corrosion pits in steels. Their sides were nearly parallel and normal to the plane of the plate and were larger in diameter underneath the surface. A transverse section was cut through the weld bead to examine these voids in more detail. A section through the weld after polishing and etching is shown in Figure 3. The clean, smooth walls of the cavities and those which had no access to the surface indicate that they were due to entrapment of gas during the welding operation.

Figure 3. A transverse section through the pitted portion of the weld bead in HS #4 steel.
